GEOMORPHOLOGIC ASSESSMENT
LITTLE STRINGYBARK CREEK

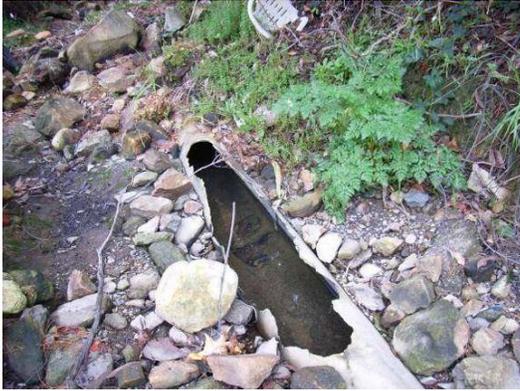
The channel within this reach alternates between low flow piped sections with an artificial floodplain, and un-piped sections where the channel is a slot approximately 1 m deep and 0.7 m wide. The banks of the stream are mainly silty clay and the bed fines downstream from coarse gravel in the headwaters to silty-clay. The coarse bed material is probably a product of an artificial valley fill that was emplaced when the low flow pipes were installed (Figure 2-13).

Figure 2-13 Exposed broken low flow pipe (looking upstream)

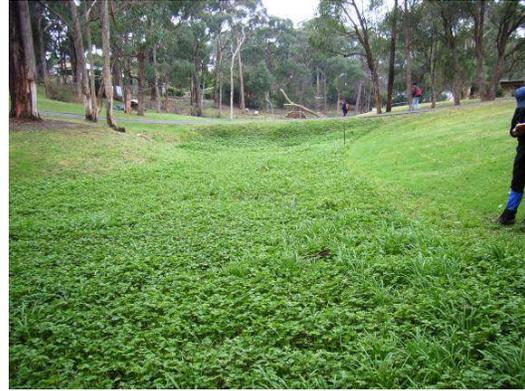
Figure 2-14 Grassed floodplain with underground pipe (looking downstream)

The valley is not very confined with a small artificial floodplain surface (Figure 2-14). Downstream of Forge Rd, the channel becomes more incised, up to 2 m deep in places. This may be a function of the stormwater inputs that enter the stream during this segment. Willows are present both on the banks and instream (Figure 2-15). Their roots have an impact on the channel with increased resistance provided by the roots leading to channel confinement. Downstream of the roots the channelised flow is more erosive and has created plunge pools. The banks of this section are vertical with some undercutting at low flow levels (Figure 2-16).

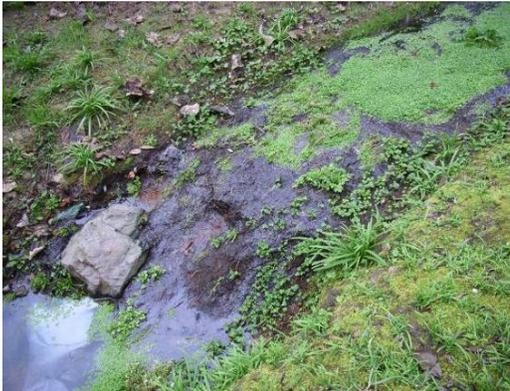
Figure 2-15 Willow root mat in the bed (looking upstream)

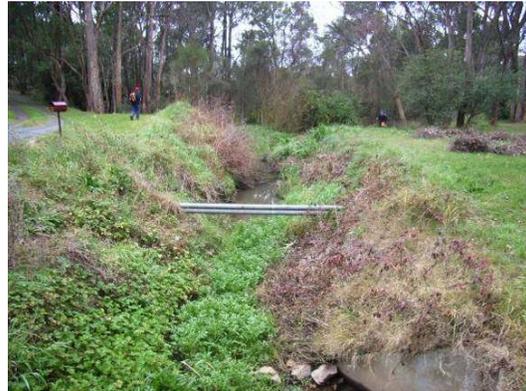
Figure 2-16 Near vertical banks of the confined upper reach (looking downstream)

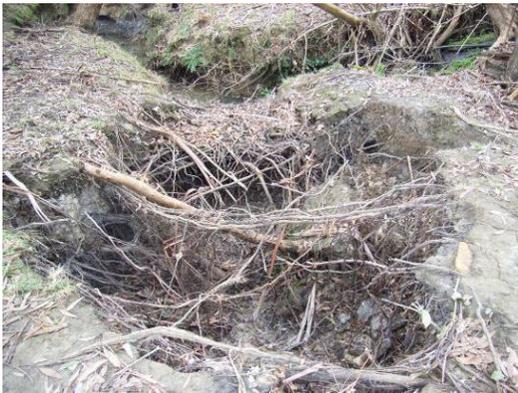
Erosion control works have been installed over sections of this reach. Downstream of a culvert (Figure 2-18) there is massive erosion. Further downstream (Figure 2-19) the channel has tortuous meanders, good riparian vegetation cover, and instream woody debris. This channel is narrower and has more bed variability.

Figure 2-18 Erosion downstream of culvert (looking downstream)

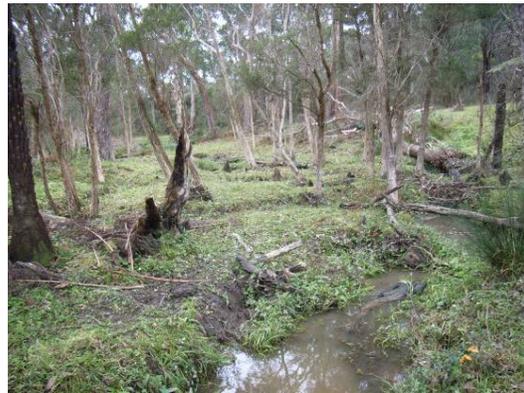
Figure 2-19 Meandering channel upstream of Evan Grove Rd (looking downstream)

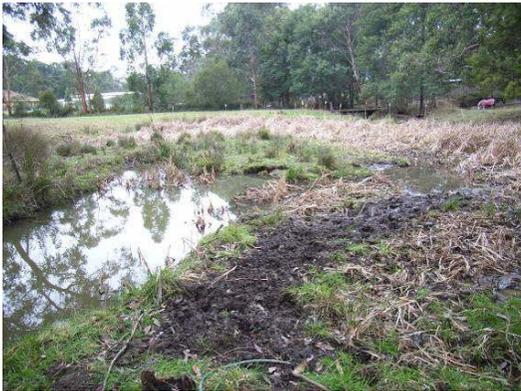
The channel becomes less well defined and more swampy (Figure 2-21) just upstream of a private access culvert. This may be due to a decrease in slope, combined with a more open floodplain. The channel downstream of the culvert shows localised erosion (Figure 2-22) and whilst there is an offline wetland downstream, localised erosion also occurs around the pipes before the next tributary confluence. More widespread incision appears to have occurred in the system and it is expected that these culverts are holding incision heads from passing up through the system. Although the channel in this section looks incised and straighter than should occur (probably attributed to artificial straightening to drain the marshy land) a secondary phase of incision is not likely given the frequency of stream crossings.

Figure 2-21 Marshy area upstream of private road crossing (upstream of Warburton highway, looking downstream)

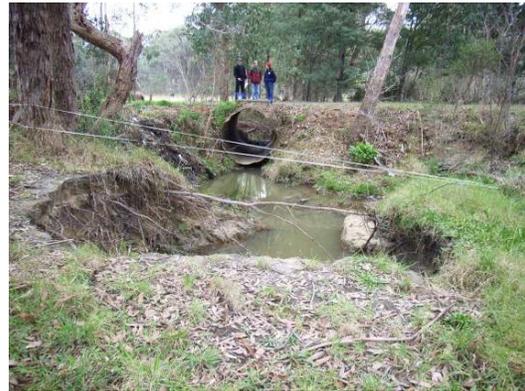
Figure 2-22 erosion downstream of stream crossing (looking upstream)

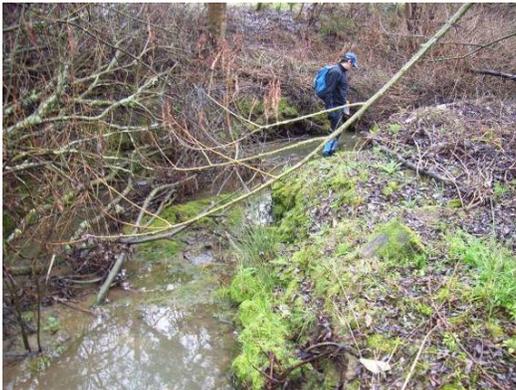
Between the Highway and Victoria Rd there is a gravel bed with bars. Willows have altered the bed, creating hard points and erosion on the opposite banks or the bed downstream (Figure 2-24). The channel is around 4 m wide and 1.5 m deep. Blackberries have invaded this reach. Downstream of Victoria Road the channel is fenced but has little riparian vegetation despite restricted grazing access. The channel is straightened and the intermittent willows again create hard points with the root systems stretching across the channel. In the area of willows the channel is shallow and narrow followed by a deeper wider sections downstream.

Figure 2-24 Willows lining the creek downstream of the Warburton Highway (looking downstream)

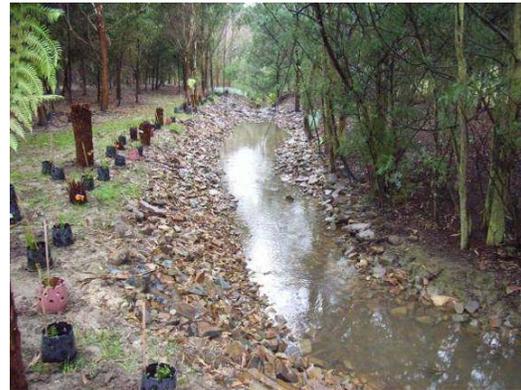
Figure 2-25 Bed and bank rock protection upstream of most upstream rock chute (looking downstream).

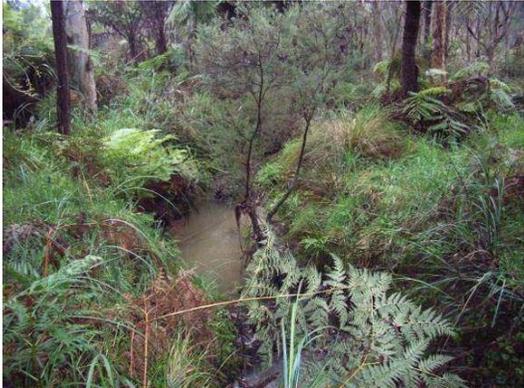
Figure 2-26 Meandering, heavily vegetated section of the creek (looking downstream)

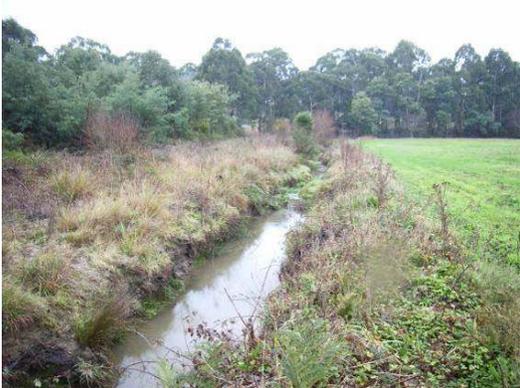
Outside the densely vegetated section the stream continues to meander but it is not as sinuous (Figure 2-27). Grazing is up to the stream edge and the channel is much narrower with sections of around 0.4 m in width. Just upstream of the reservoir there is a marshy area where the flow backs up during flood events.

Figure 2-27 Straightened section of creek (looking downstream)

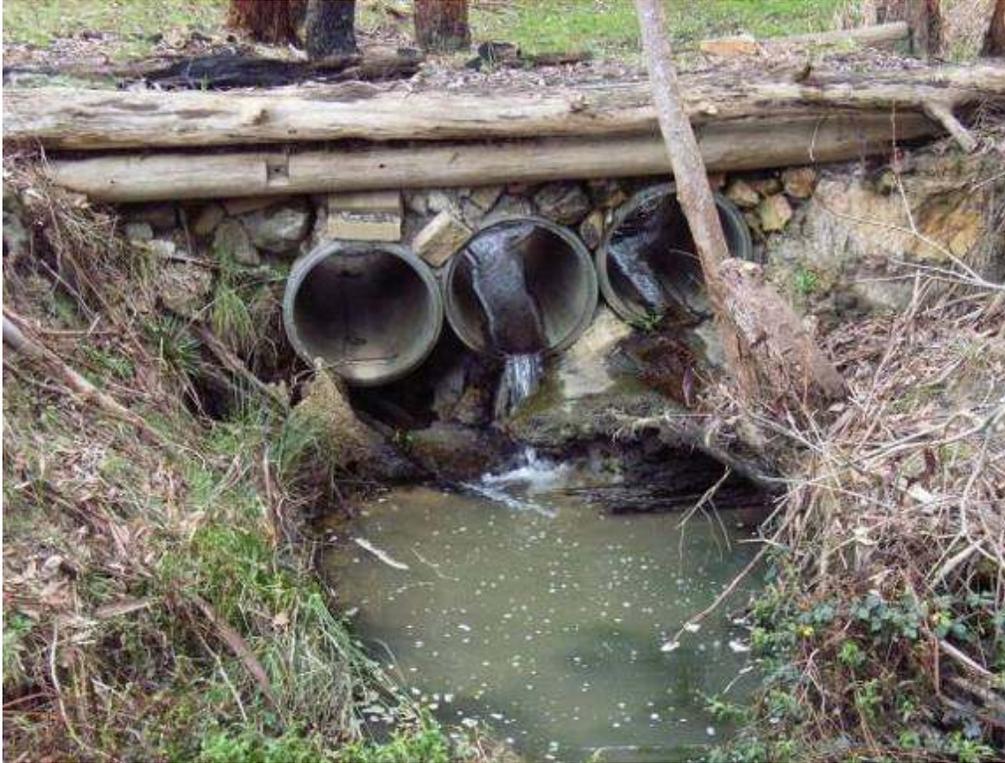
Substantial scour was observed immediately downstream from a number of culverts. An example of this scour is shown in Figure 2-29.

Figure 2-29 Instability downstream of channel crossings. Photo taken between reach 2 and 3 (looking upstream).
