GEOMORPHOLOGIC ASSESSMENT
LITTLE STRINGYBARK CREEK

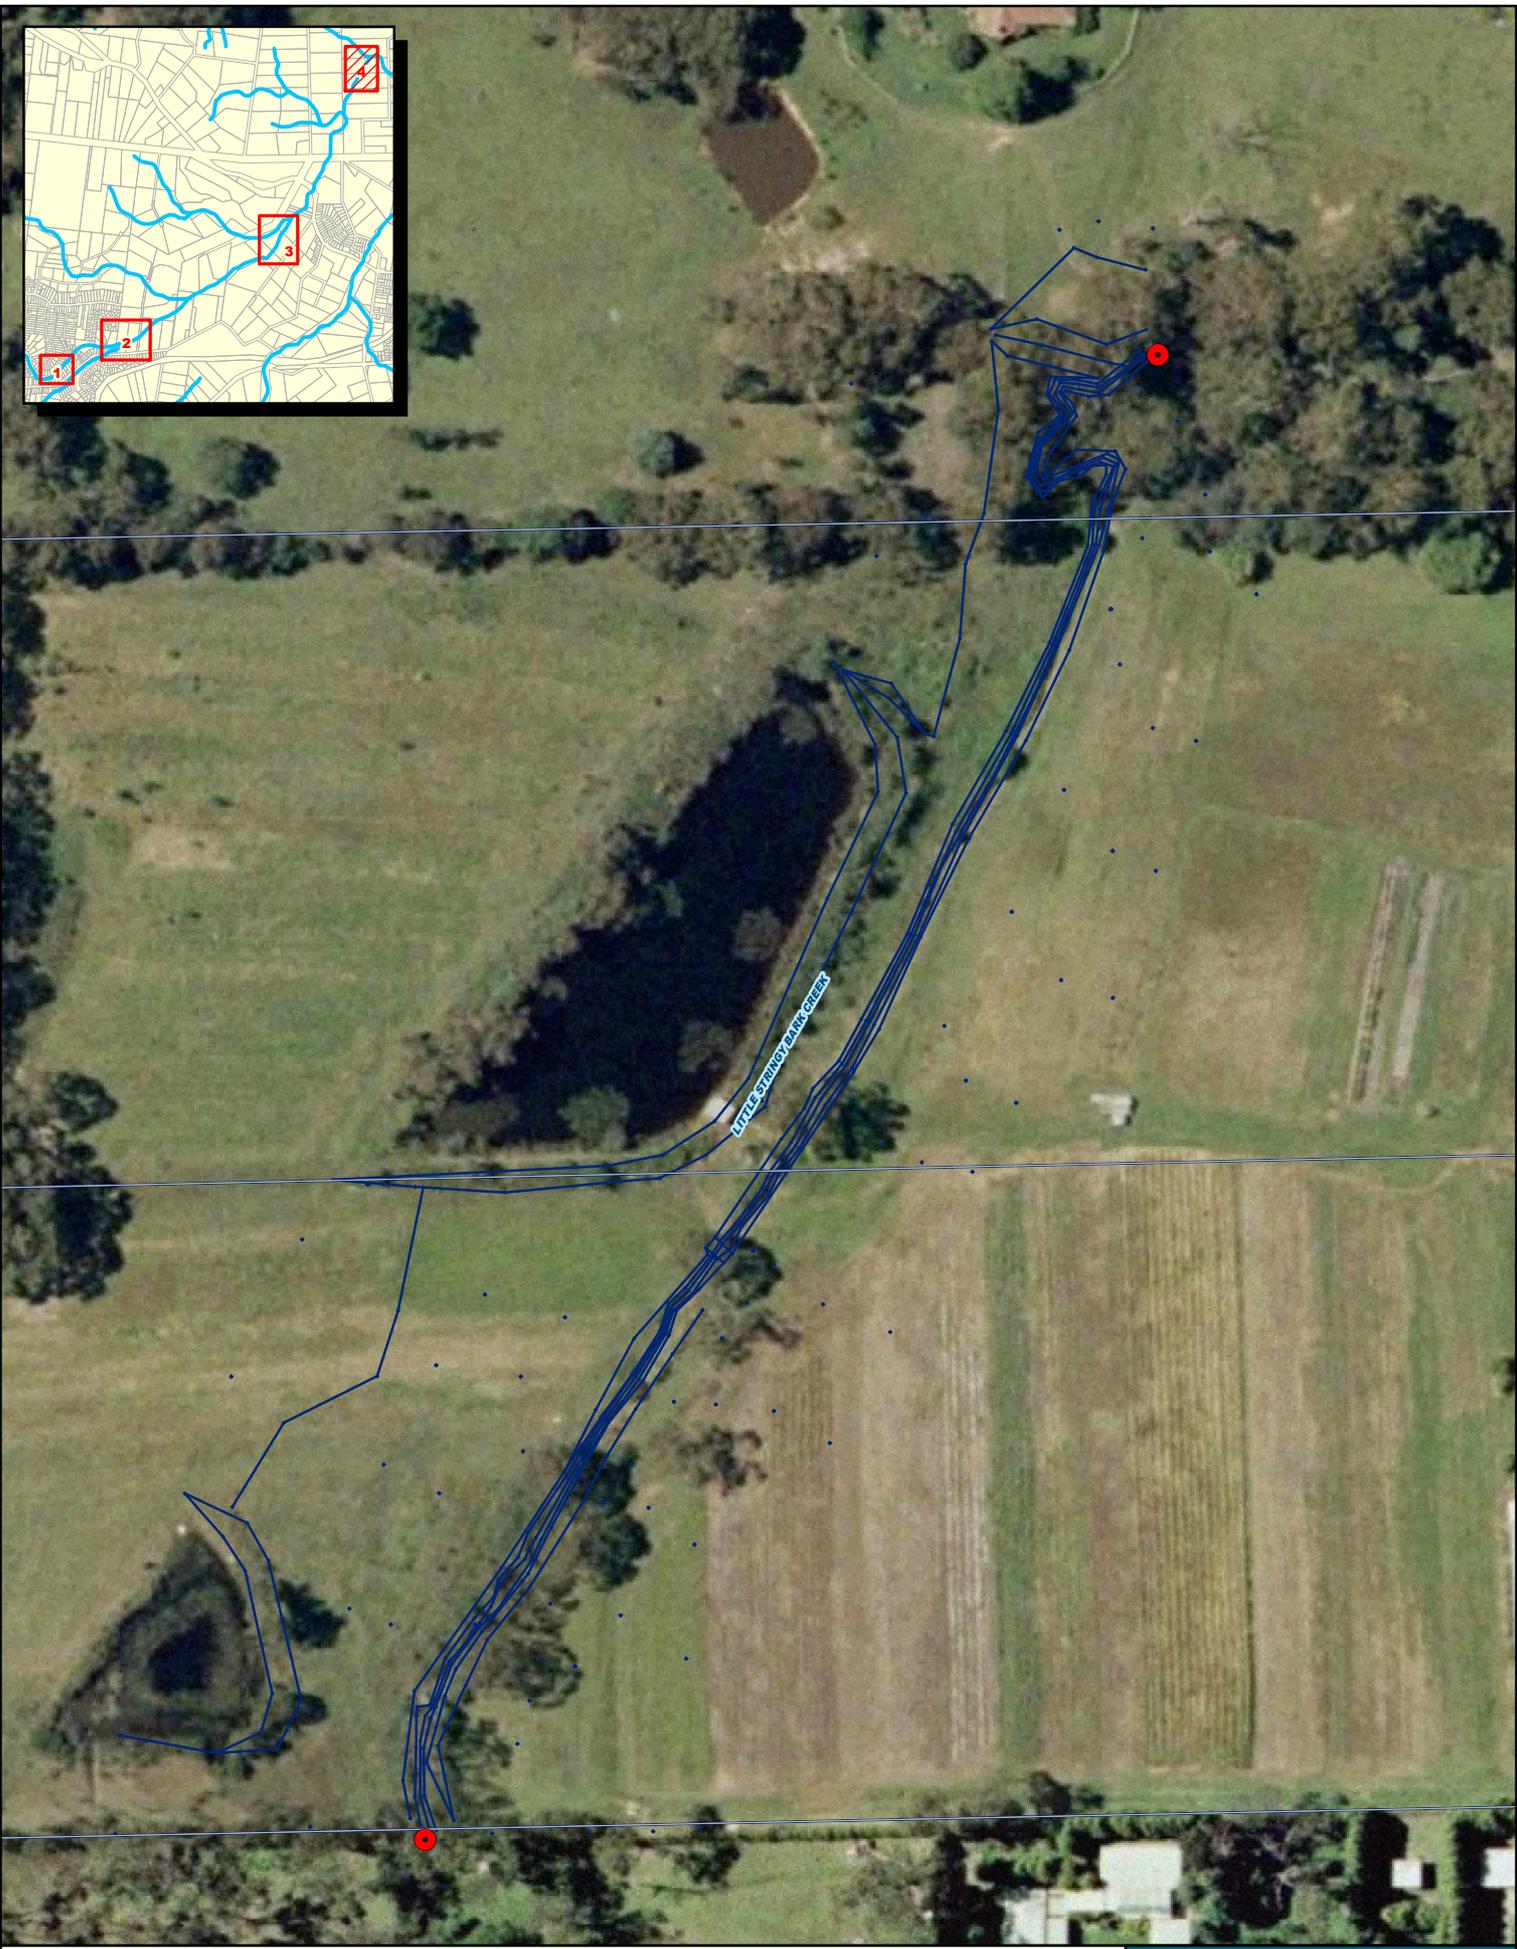
Figure 2-27 Straightened section of creek (looking downstream)

Outside the densely vegetated section the stream continues to meander but it is not as sinuous (Figure 2-27). Grazing is up to the stream edge and the channel is much narrower with sections of around 0.4 m in width. Just upstream of the reservoir there is a marshy area where the flow backs up during flood events.

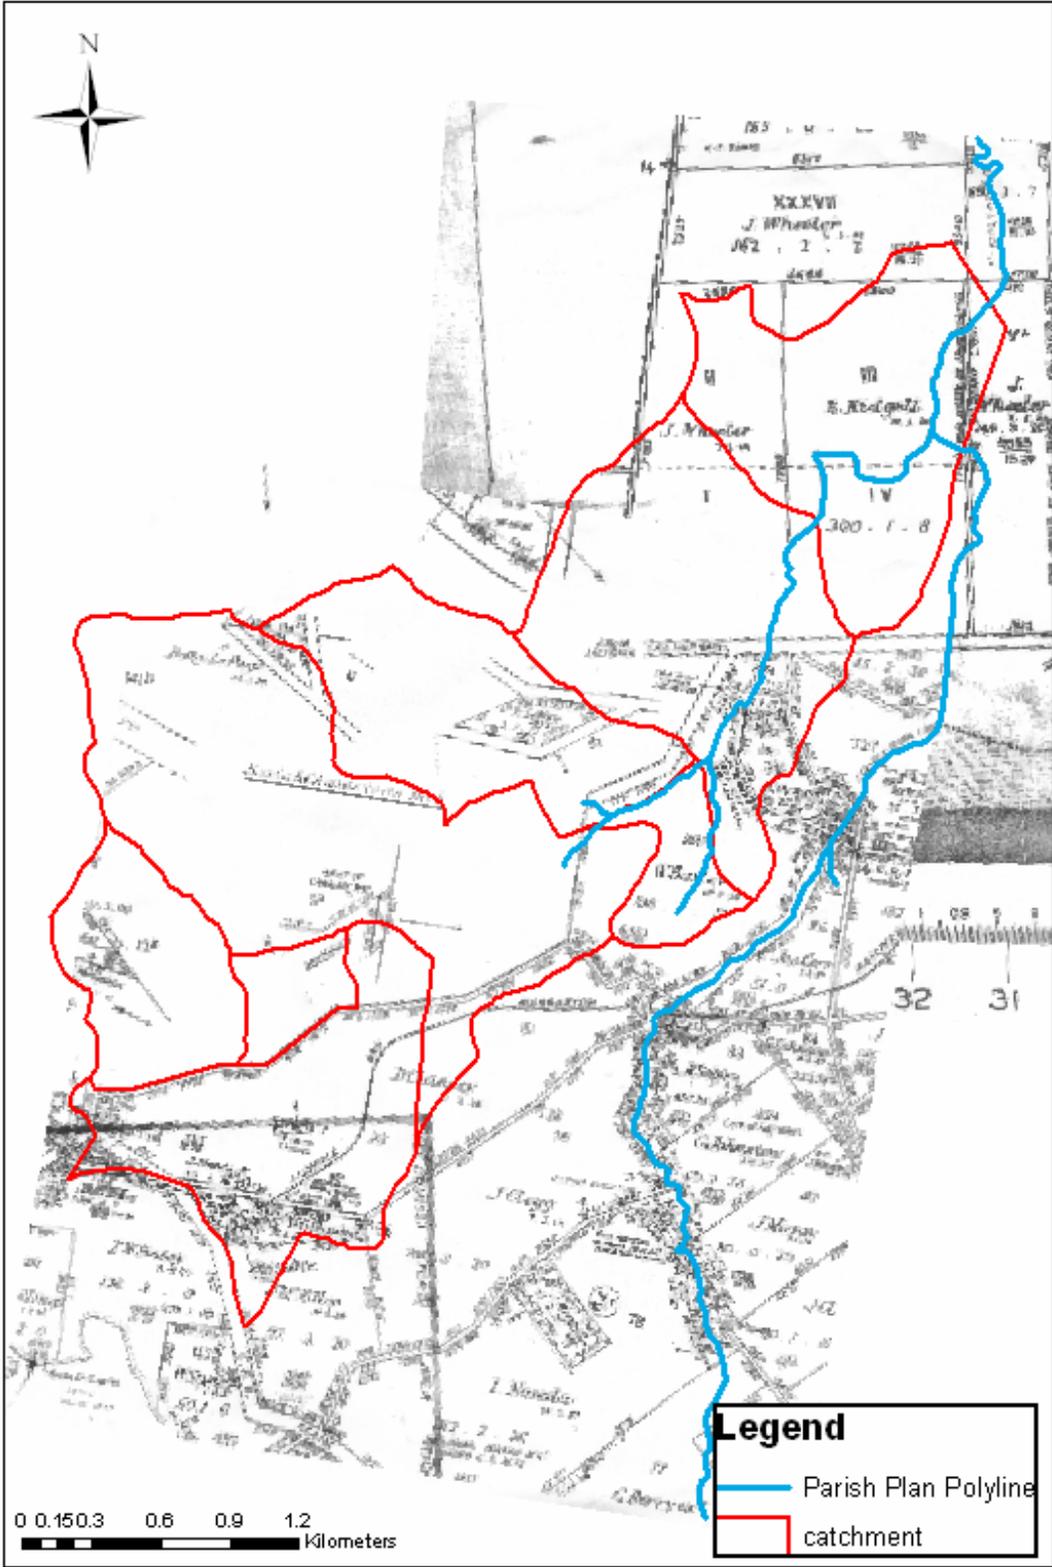
Figure 2-30 Stream line from Parish Plan circa 1900

The stream network has been identified in each plan and from the aerial photographs. These networks have been traced and compared. The traced stream lines appear to show a much smaller channel network in the Parish Plan dated at around 1900 (Figure 2-30) than the contemporary stream network (Figure 2-33). This suggests that the stream network has increased in length, and that the upper stream reaches may have consisted of undefined or discontinuous stream type such as a swampy marsh.

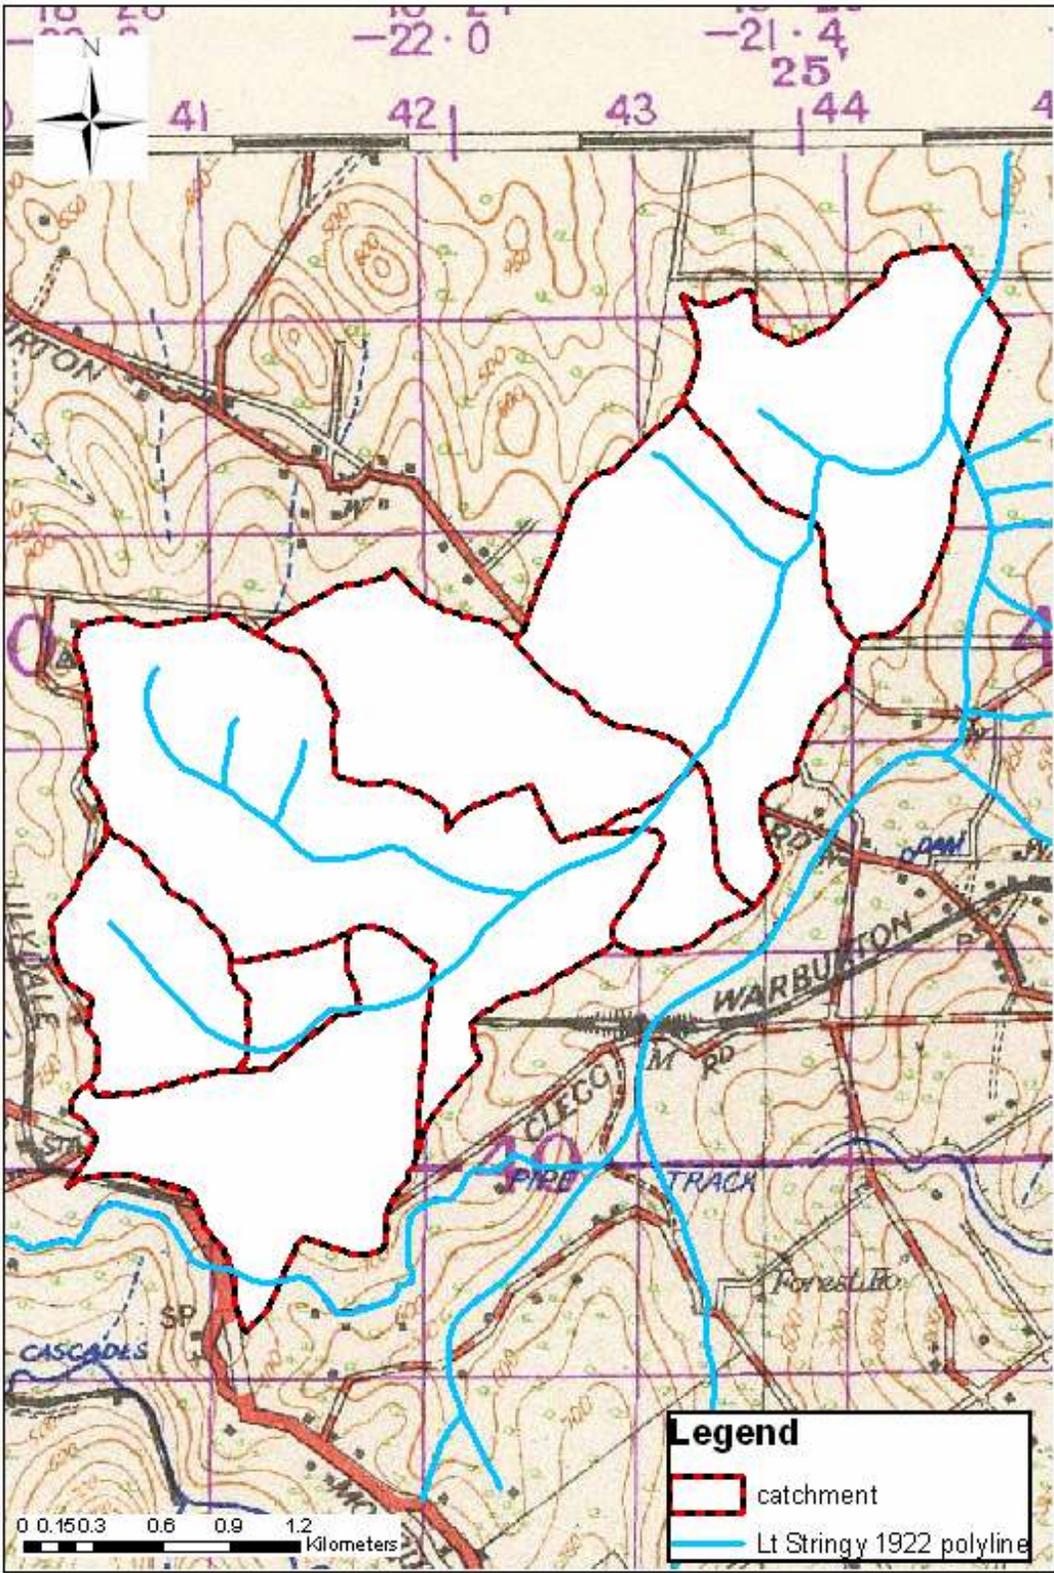
Figure 2-31 Stream line from 1922 map

The 1922 map (Figure 2-31) shows a much greater network of streams across the catchment. The 1940's aerial photo (Figure 2-32) is difficult to interpret. Wet road surfaces, and other reflective linear features, could be misconstrued as the stream. Vegetation near the stream channel also make identification of stream patterns less accurate. The overall picture appears to be of much the same stream pattern in the lower catchment, but a less dense stream network in the upper catchment. Initial channel development since major clearance may have halted, resulting in revegetation of sections, and the reduced visibility of some of the channels.

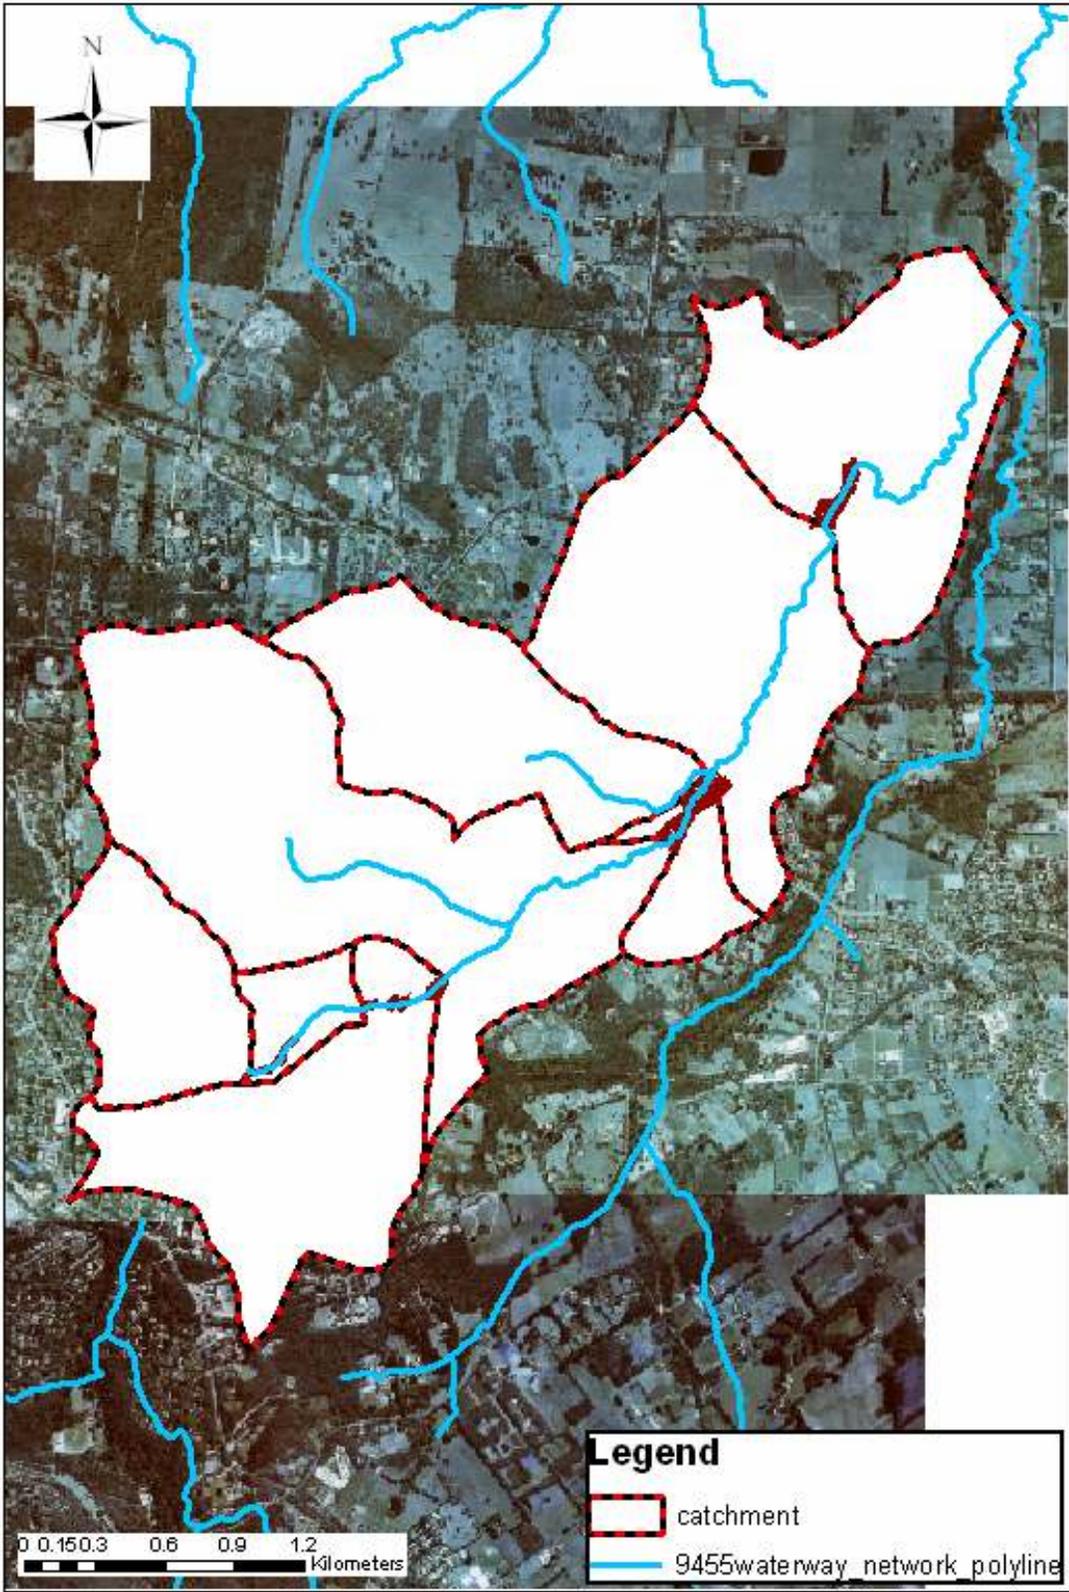
Figure 2-33 Stream line from 2005 aerial photograph

The current aerial photography (Figure 2-33) shows a stream network that extends up into the upper catchment but with less extensive tributaries than the 1922, and 1940's images. This may be a result of contemporary urban drainage systems replacing much of the incised streams in the upper catchments.

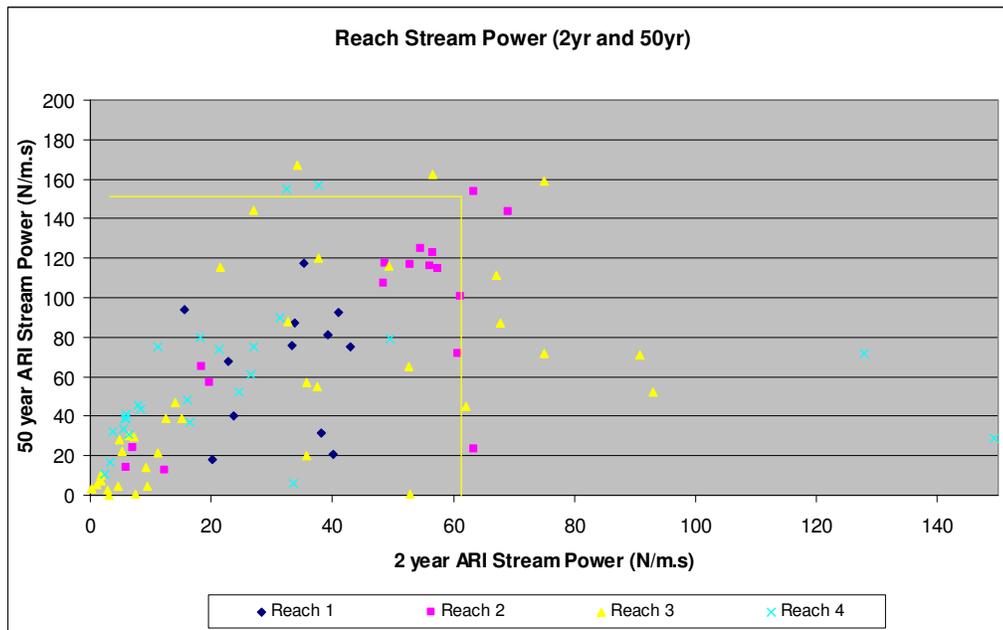
The results show that the stream power for the reach 1 representative site are typically lower than that for other stream reaches. The modelling results are consistent with field observations which noted no active incision of the wide, shallow grassed channel at the representative site. All cross sections analysed for the representative site in reach 1 were found stream power below the thresholds found for non eroding, incised streams of central Queensland.

Figure 2-35 2 year and 50 year ARI Stream Power in all study reaches. The yellow lines indicate the highest unit stream powers identified in non eroding, incised streams of central Queensland (all systems with unit stream powers above these values were eroding).

Analysis of the stream power for reaches 2, 3 and 4 found it to be higher than that for reach 1, with many cross sections exceeding the unit stream power found for non eroding incised stream reaches in central Queensland. Field observations of these downstream reaches revealed localised instability at and downstream of channel crossings. Without intervention, Little Stringybark Creek will continue to experience instability around channel crossings.

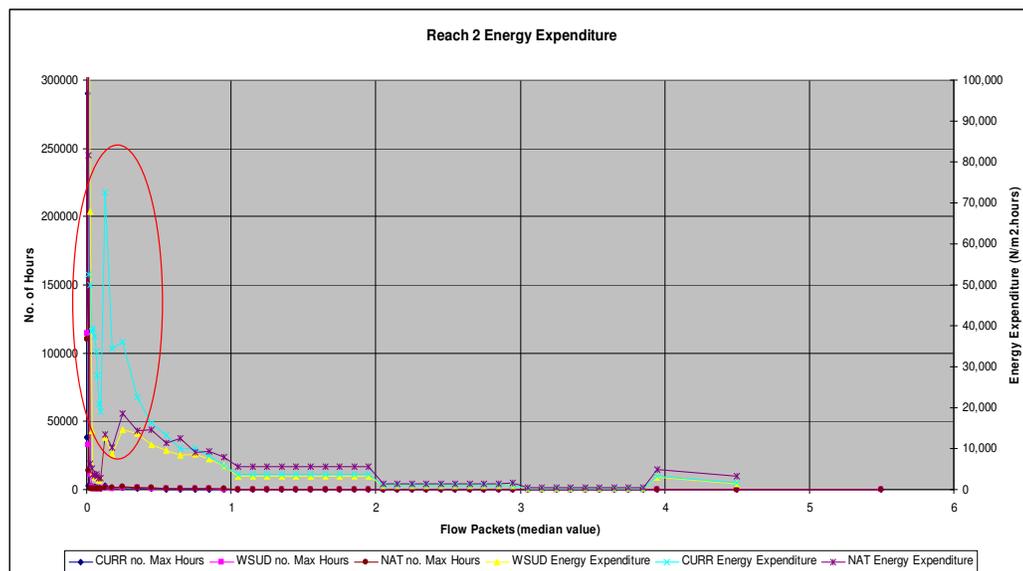
Figure 2-36 Reach 2 Energy Expenditure

In all study reaches, the introduction of urbanisation resulted in a marked increase in the total energy expenditure energy over that found for the forested/ cleared catchment scenario (for the 40 year hydrologic record). The greatest relative difference in energy expenditure occurs in the upper reaches of the creek and at low flows. The results for reach 2 are shown in Figure 2-36.

Analysis of the total energy expenditure results suggests that a change in the flow regime associated with urbanisation may have the capacity to create channel change. The results also show that the introduction of WSUD can return the flow regime to something that approximates the intact flow regime.

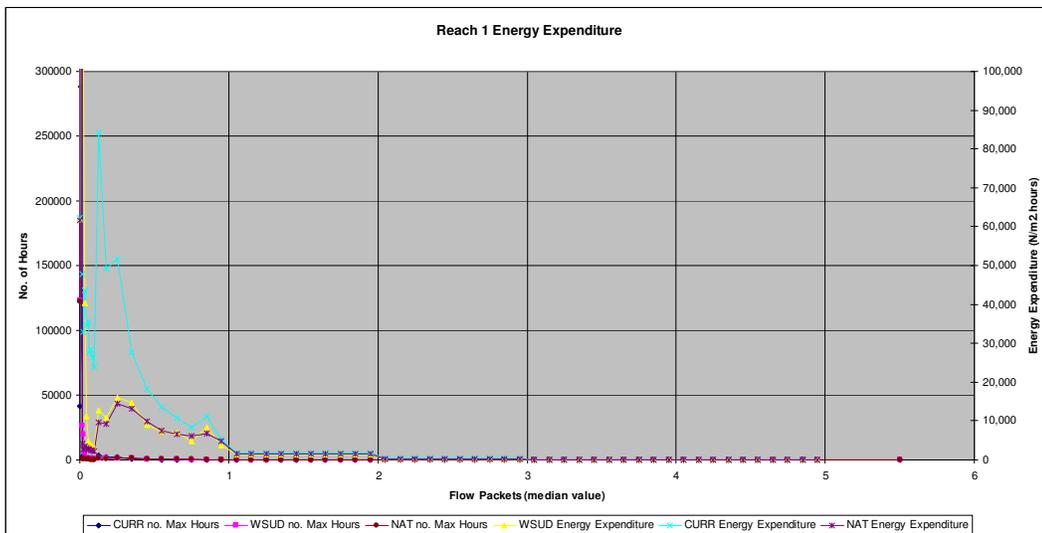
Figure 2-37 Reach 1 Energy Expenditure

In reach 1, the urbanised upper catchment, WSUD influences the energy expenditure for flow events less than 1m³/s (Figure 2-37). This range of flow events decreases as the distance from urbanisation increases, with reach 4 only depicting a reduction in energy expenditure for flows up to approximately 0.4m³/s (Figure 2-38).

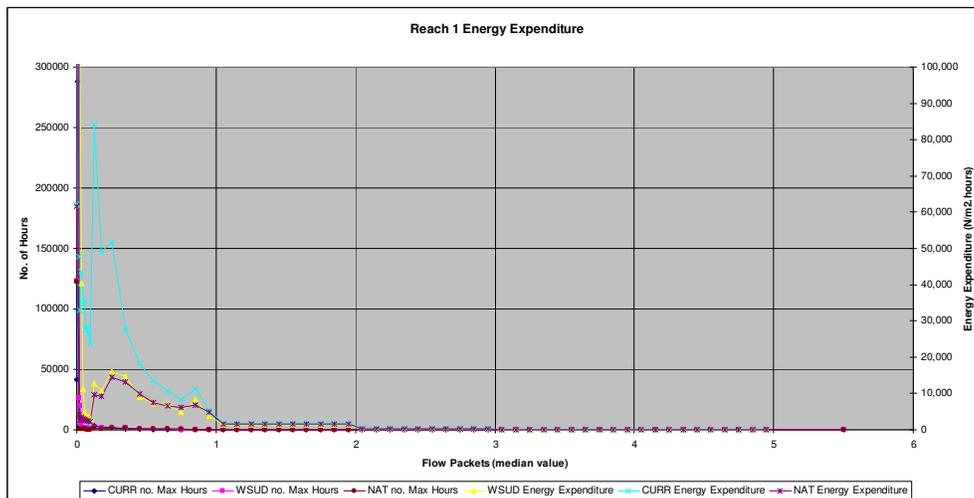
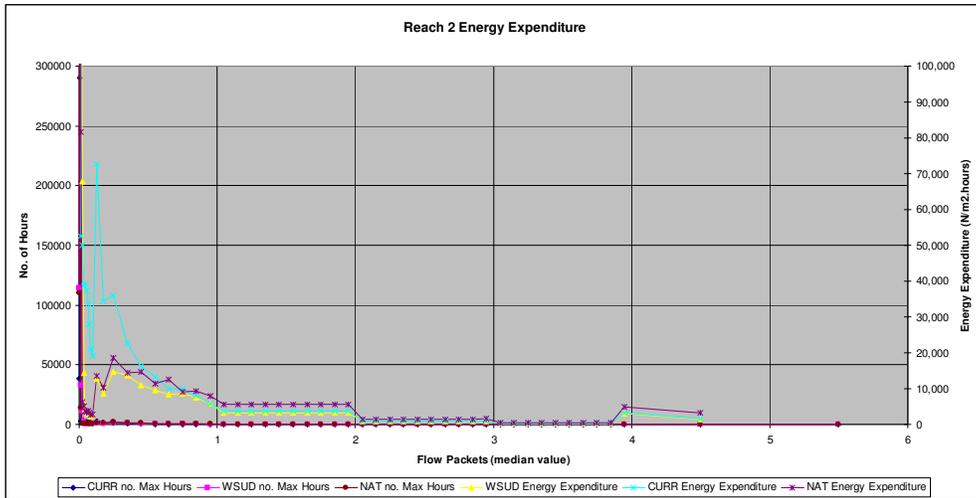
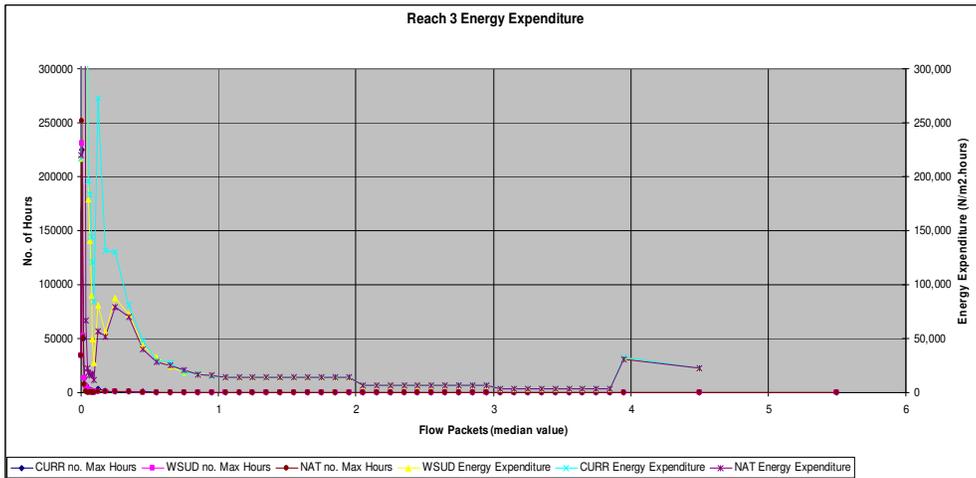
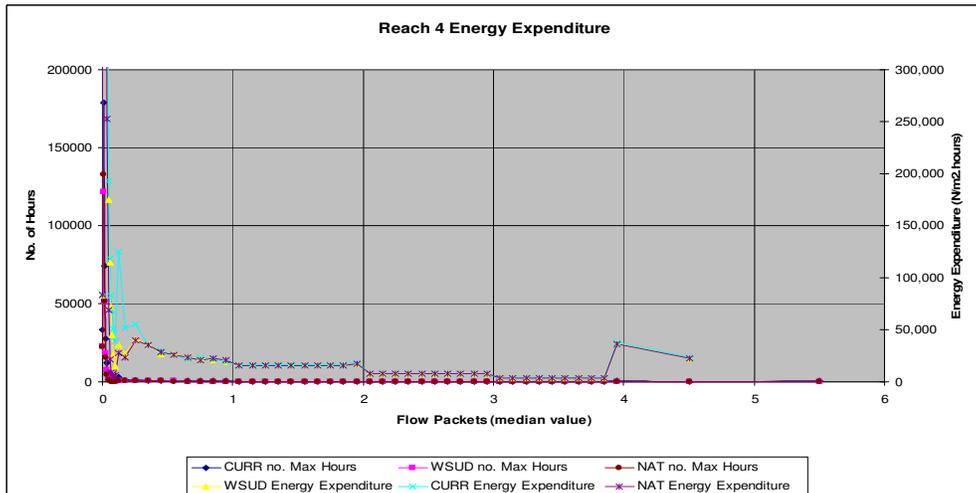
The areas under the excess energy expenditure curves (Figure 5-7, Figure 5-8, Figure 5-9 and Figure 5-10) were compared and the relative change in energy expended in each development scenario determined (Table 5-3).

A reduction in the energy expended in these reaches would decrease the rate of bed and bank material movement in the system. With a sufficient sediment supply, the bed of the channel may increase in diversity. This is not likely as the sediment supply to the catchment is currently limited (and will be more limited under WSUD).

Therefore, under WSUD conditions, it is expected that the rate of localised erosion and instability will reduce. Ongoing stream processes, such as instability around channel crossings, will however still influence the physical form of the channel under WSUD conditions as this process is not dependent on low flow conditions.
